Catch Basin Repair Pictures

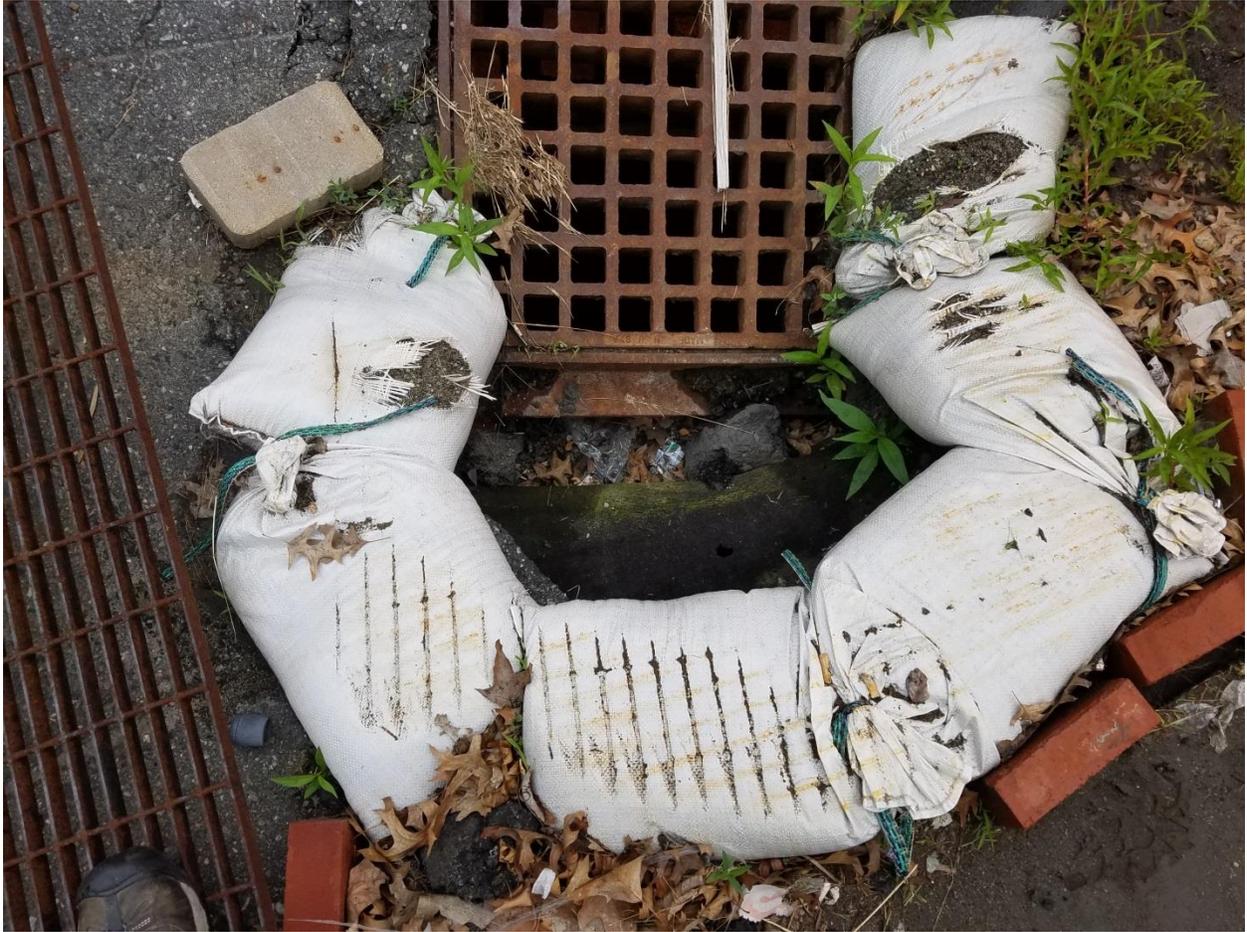
Building 1 Catch Basin

This is behind building 1. The concrete portion of the basin is intact. The pavement needs to be cut back, refilled and compacted and have the supporting brick with mortar replaced , and repaved.

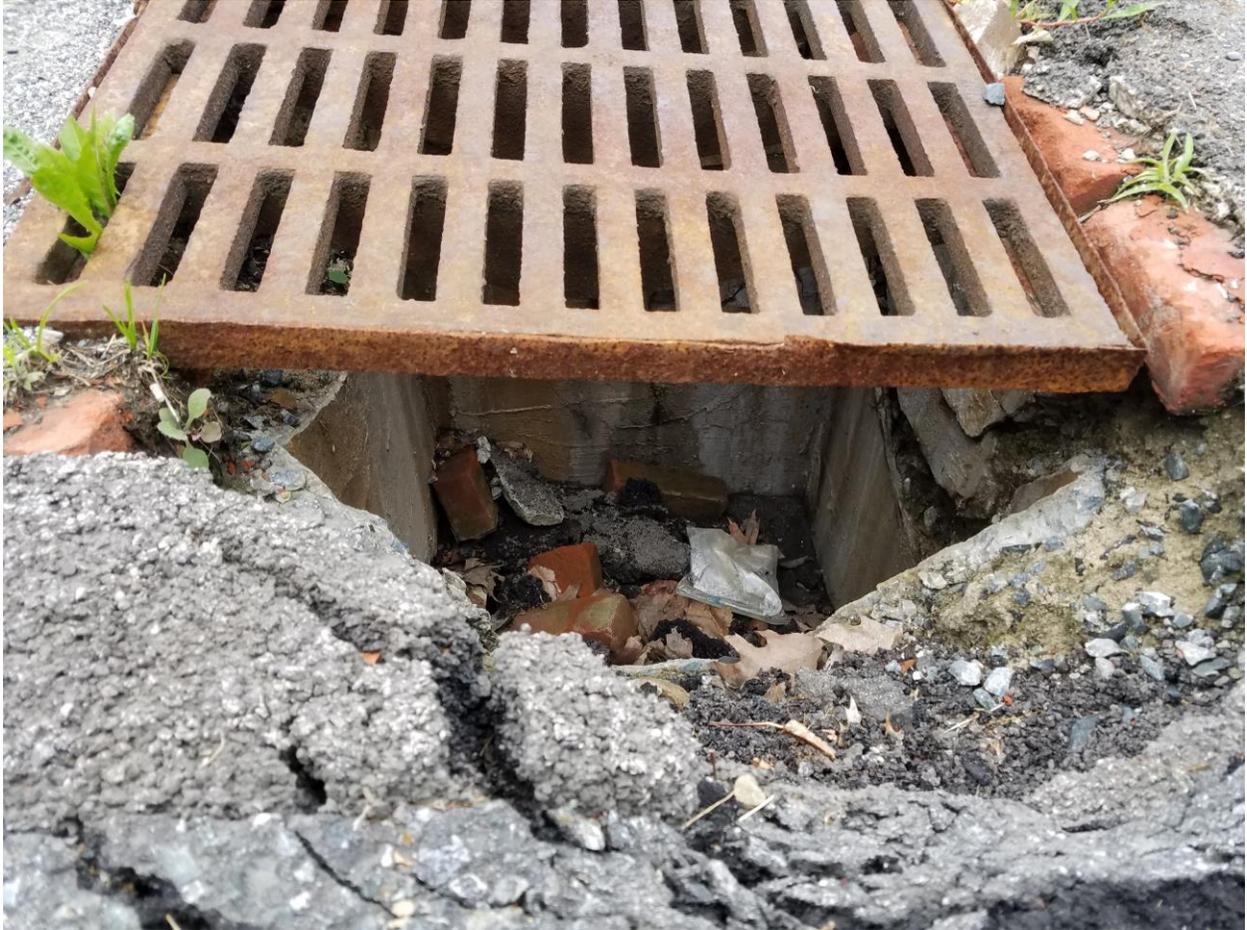
Lot 5 Catch Basin

The concrete in this basin is damaged, however instead of disturbing all the banking the drainage runs through it may be best to excavate around and re-pour to make basin whole again and have added strength.
